Maintenance of the deteriorated infrastructure in Thailand

Abstract

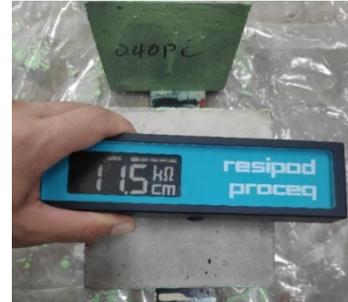
Figure 1. Measurement of concrete electrical resistivity.

Concrete with different mix proportions such as water to binder ratio (0.4 and 0.6), types of binder (OPC and 30% fly ash replacement), and chloride content (0, 2, and 6 kg·m⁻³) were used to prepare 15 cm cube plain concrete specimens. Specimens were cured by plastic wrapped for 28 day before conditioning in high relative humidity sealed container. Electrical resistivity was measured at 30, 60 and 150 day on a side surface of specimens after being conditioned by Wenner's four probe method as shown in Figure 1.

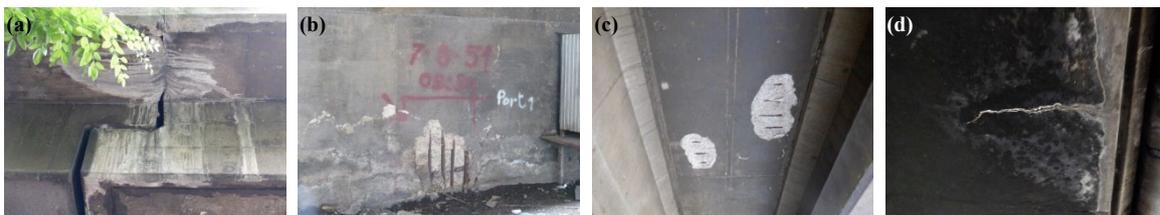
Figure 4. Damage observed by visual inspection (a) water leakage (b) spalling (c) spalling and delamination (d) crack.

with high safety factor in the past. Figure 4 shows examples of damage frequently being observed. Water leakage due to joint damage or drainage system failure is the majority type of found damage. Even water leakage does not affect structural safety, but corrosion rate of reinforcing steel is increased and shortens the service life of structure. Consequence damage generated due to water leakage is also difficult to repair because of limited space. This will cause a large amount of repair budget in the future. Other damage observed were cracking, delamination, spalling of concrete surface.
